NEW YORK STATE DEPT OF ENVIRONMENTAL CONSERVATION ALBANY F/6 13/13
NATIONAL DAM SAFETY PROGRAM. WARNER DAM, CHAUTAUGUA LAKE OUTLET--ETC(U)
SEP 80 B L THOMSEN, G L WOOD

REPORT DOCUMENTATION PAGE		READ INSTRUCTIONS BEFORE COMPLETING FORM
1. REPORT NUMBER	2. GOVT ACCESSION NO.	3. RECIPIENT'S CATALOG NUMBER
	AD-A090 937	
4. TITLE (and Subtitle) Phase I Inspection Report Warrer Dam-Chautauqua Lake Outlet Allegheny River Basin, Chautauqua County, New York Inventory No. 750		5. TYPE OF REPORT & PERIOD COVERED Phase I Inspection Report National Dam Safety Program

PHASE I INSPECTION REPORT
NATIONAL DAM SAFETY PROGRAM
WARNER DAM
I.D. NO. N.Y. 750
ALLEGHENY RIVER BASIN
CHAUTAUQUA COUNTY, NEW YORK

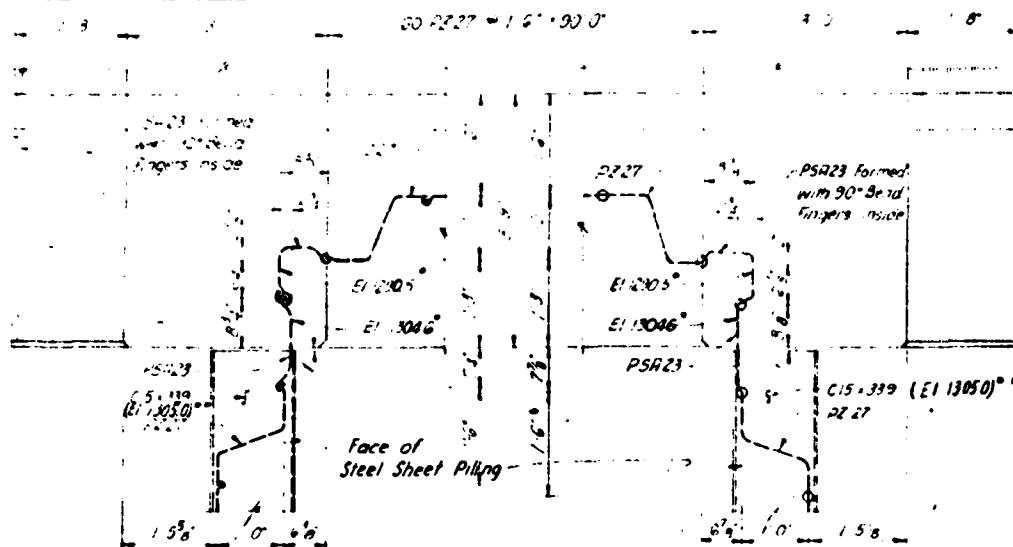
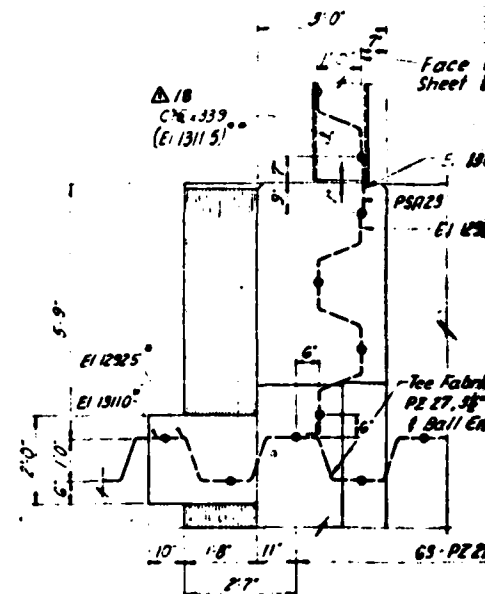
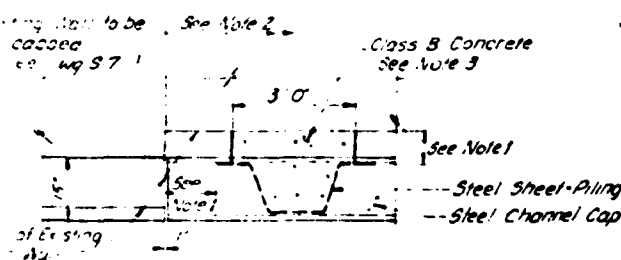
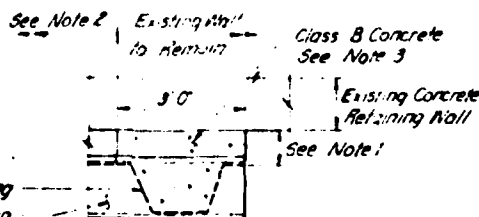
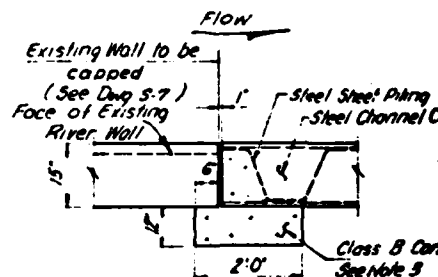
CONCRETE WALL REPAIR DETAILS

1. Contractor shall remove unsound concrete from top of existing wall before adding cap
2. Dimensions & elevations of existing structure shall be verified in the field by the contractor.
